Company: **Watling JCB**

Application: **Earthmovers/Excavators**

Component: **Electrical Connector**

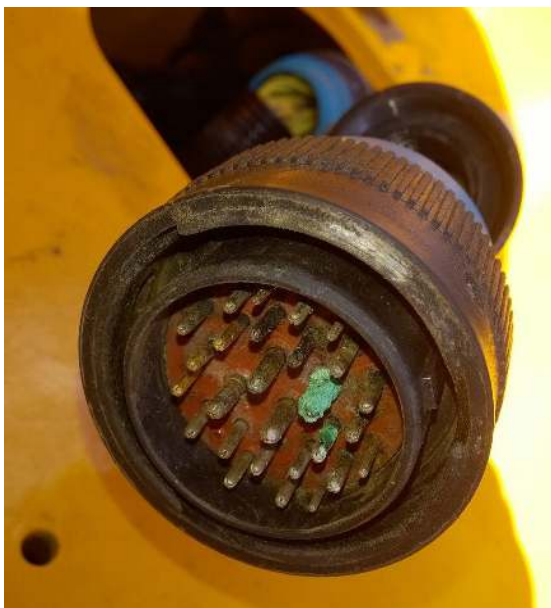
Watling JCB sell new and used JCB excavators, loaders and other JCB construction machinery. Service engineers were experiencing water ingress issues on the engine to chassis harness connector (known as the interconnect), the resulting corrosion of the connector pins causing loss of connectivity over time. This connector which has a critical role on JCB platforms, is up to 29 way, 12 volts and is an IP69 rated twist lock design. Water ingress was occurring due to capillary penetration of moisture through the gland and connector housings to the contact surface area on multiple pins. Degradation of the connector resulted in expensive and time consuming replacement of connector and loom section.

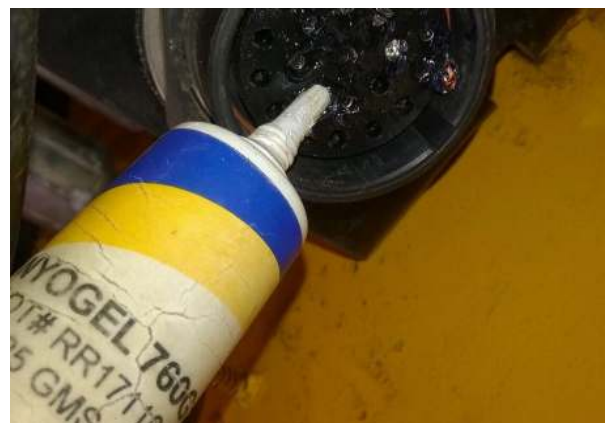
- **Nyogel 760G**

Normally only a thin coating of the Nyogel 760G is required for product to be effective, especially when the 760G is being used for fretting corrosion prevention. In this case study the grease is primarily being used as a moisture barrier so it is important that the grease is applied to all the points of moisture entry. A liberal application of the 760G is recommended but care should be taken not to overfill this JCB connector as it is sealed/IP rated, so excess grease cannot escape out through the back of the connector.

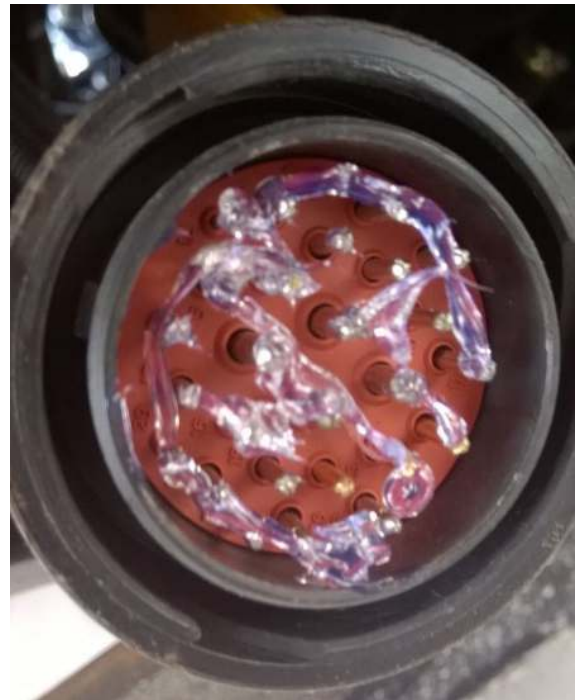
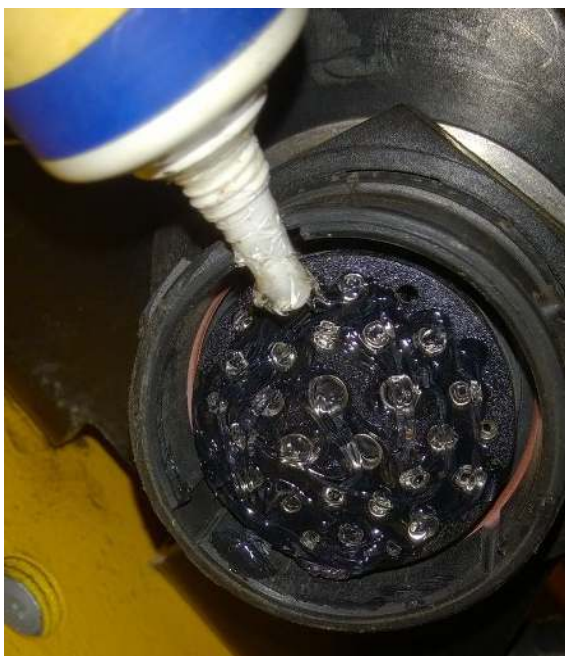
Most JCB service engineers treat both the male and female side of the connector to ensure every contact area is treated.
